REGIONAL MEMORANDUM
No. 322 - 2019

**VALIDATION OF SCHOOL LOCATIONS ON THE HAZARD HUNTER PH MAP AND
ACCOMPLISHMENT OF THE ASSESSMENT CHECKLIST FOR SCHOOLS' LANDSLIDE SAFETY**

MEMORANDUM No. 52, S. 2019

SUBJECT : ACCOMPLISHMENT AND SUBMISSION OF THE ASSESSMENT
CHECKLIST/S FOR SCHOOLS' LANDSLIDE SAFETY

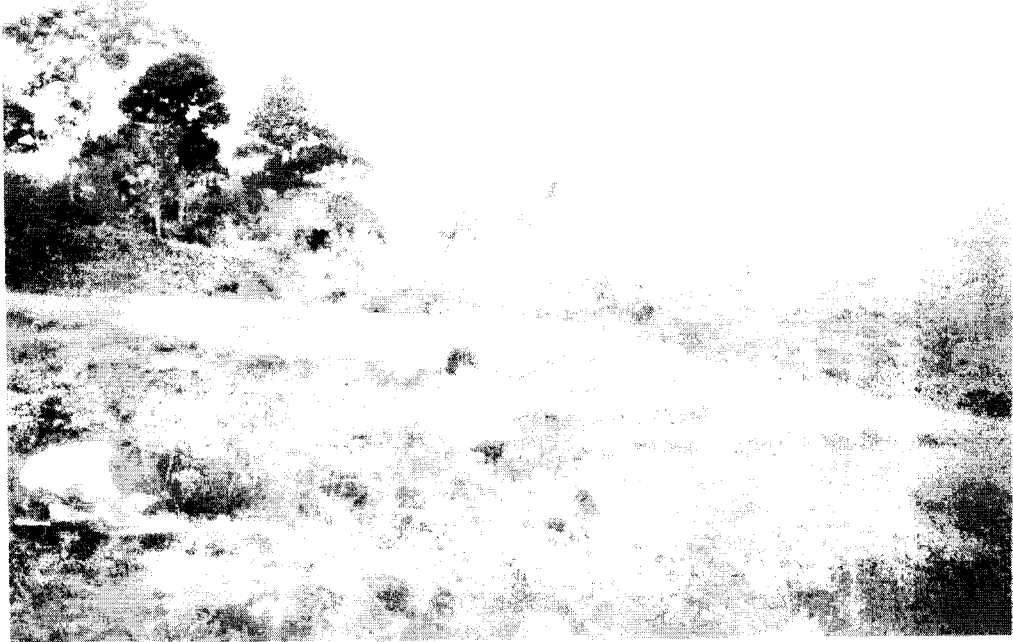
3. In geomorphology, a **terracette** is a type of landform, a ridge on a hillside formed when saturated soil particles expand, then contract as they dry, causing them to move slowly downhill.

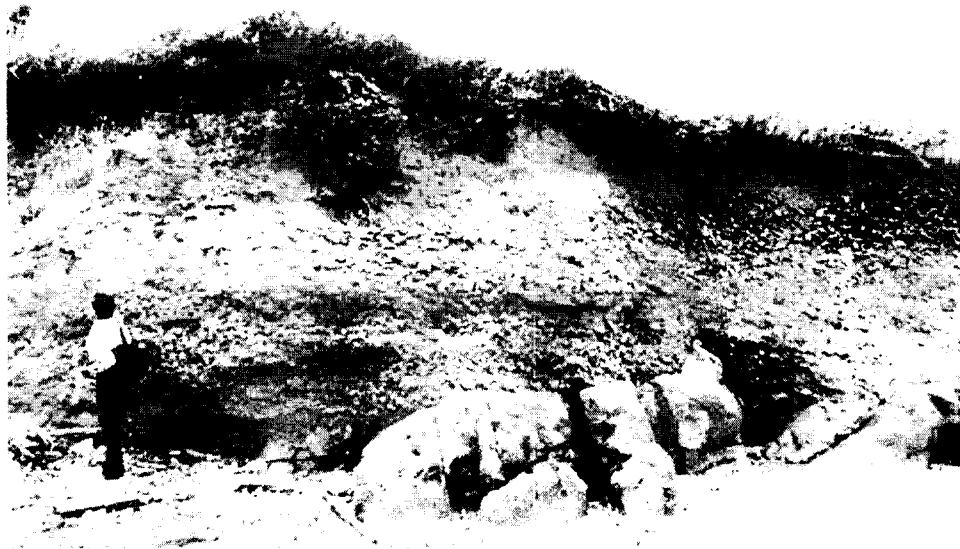
6. **Alluvium** is loose, unconsolidated soil or sediment that has been eroded, reshaped by water in some form, and re-deposited in a non-marine setting. Alluvium is typically made up of a variety of materials, including fine particles of silt and clay and larger particles of sand and gravel.
